Service Bulletin

ISSUE NO.:CRT03-006

2. SUBJECT:Countermeasure of R556 broken (Revise of CRT02-002)

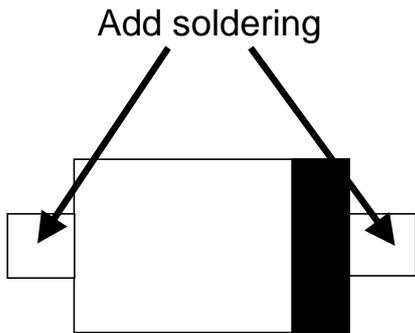
- a) Partial soldering of D501 on OSC PWB.
- b) Parts problem of IC541 on OSC PWB.

(1) Add soldering on lead of D501.

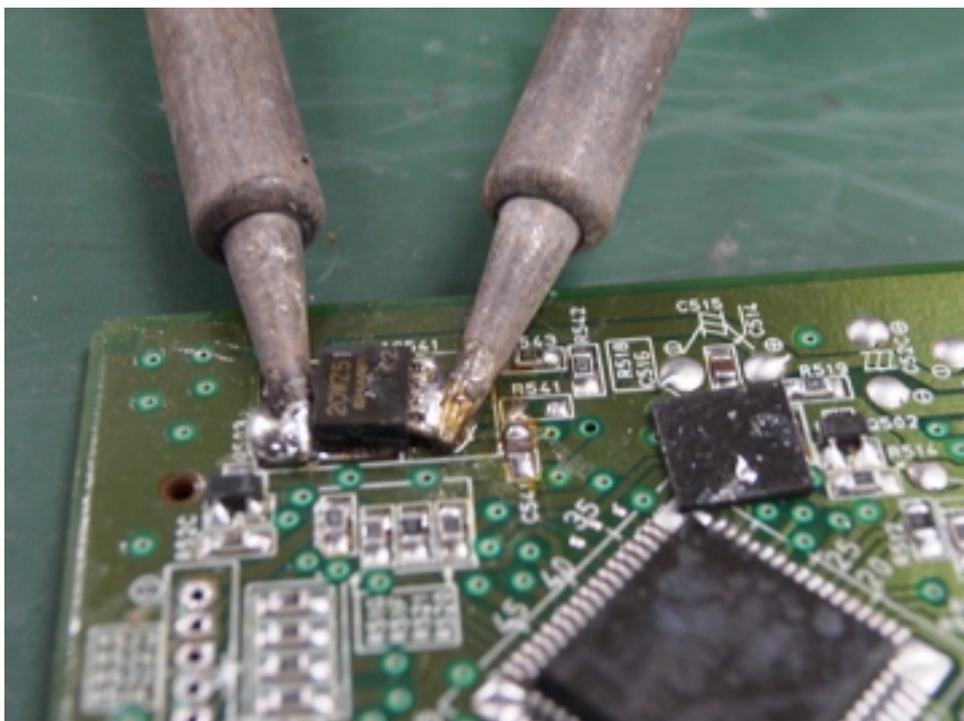
The result of cause investigation to which R556 becomes open, it turns out that IC541 which is power regulator for IC501 is operating incorrectly. It is thought that IC541 has received damage, point of bonding wire inside of IC has stress with over heat or abnormal welding conditions.

c) Heat IC541's 5 leads and head of body (fin) at the same time with 2 soldering irons. When the solder is melted, take IC541 with pliers. Please do not heat it to excess. If it's too much to heat, soldering pad will be lifted.
