Repair Information VCR04/09

Turbo drive deck

VCR: Paolina, Queen, Apollo

TVCR: Alpha, Beta, Gamma, Delta, Epsilon

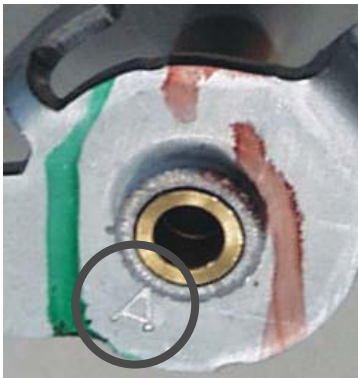
Tape damage during loading and minimal contact force of pressure roller causes tape path problems after having replaced the pressure roller by a new one without an "A" stamped on the metal pate underneath see picture.

Manufacturing tolerances

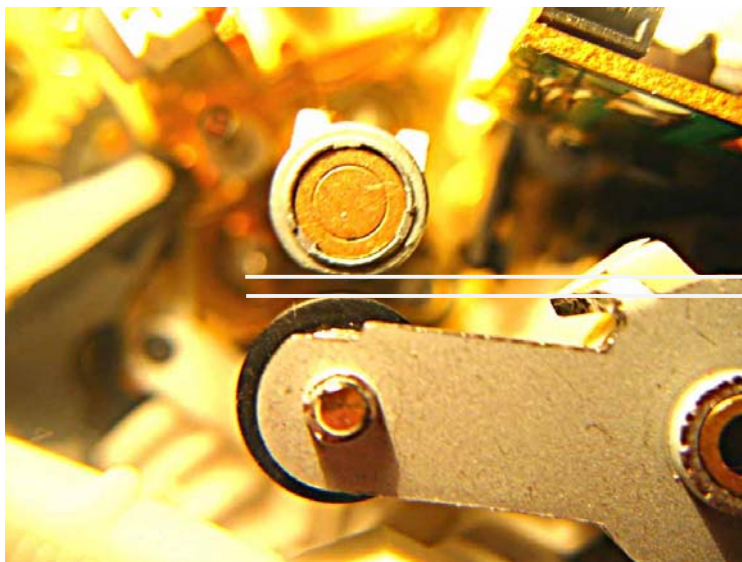
- 1.) Check position of pressure roller to capstan motor in 'Eject'

Distance should be:
about 1 to 2 mm

- 2.) If this distance is bigger than 1 to 2 mm the following modification is required
- a.) Original delivered pressure roller

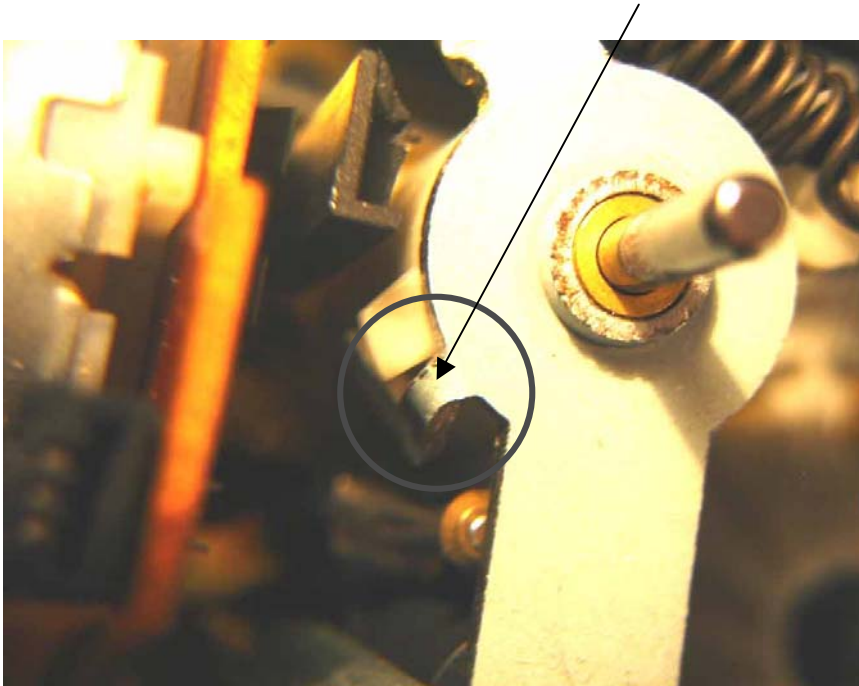
- 1.) Connect the set to power
- 2.) Put in an old tape
- 3.) Press the "play" button on the set -> the set play's back the tape
- 4.) The modification is good there is a small gap between the bended metal angel of the pressure roller and the plastic nose when looking from the top.
- 5.) If this is not the case bend a bit more and check again
