JVC

A-GX3

DIAGRAM MANUAL

6. A-GX3 Schematic Diagram

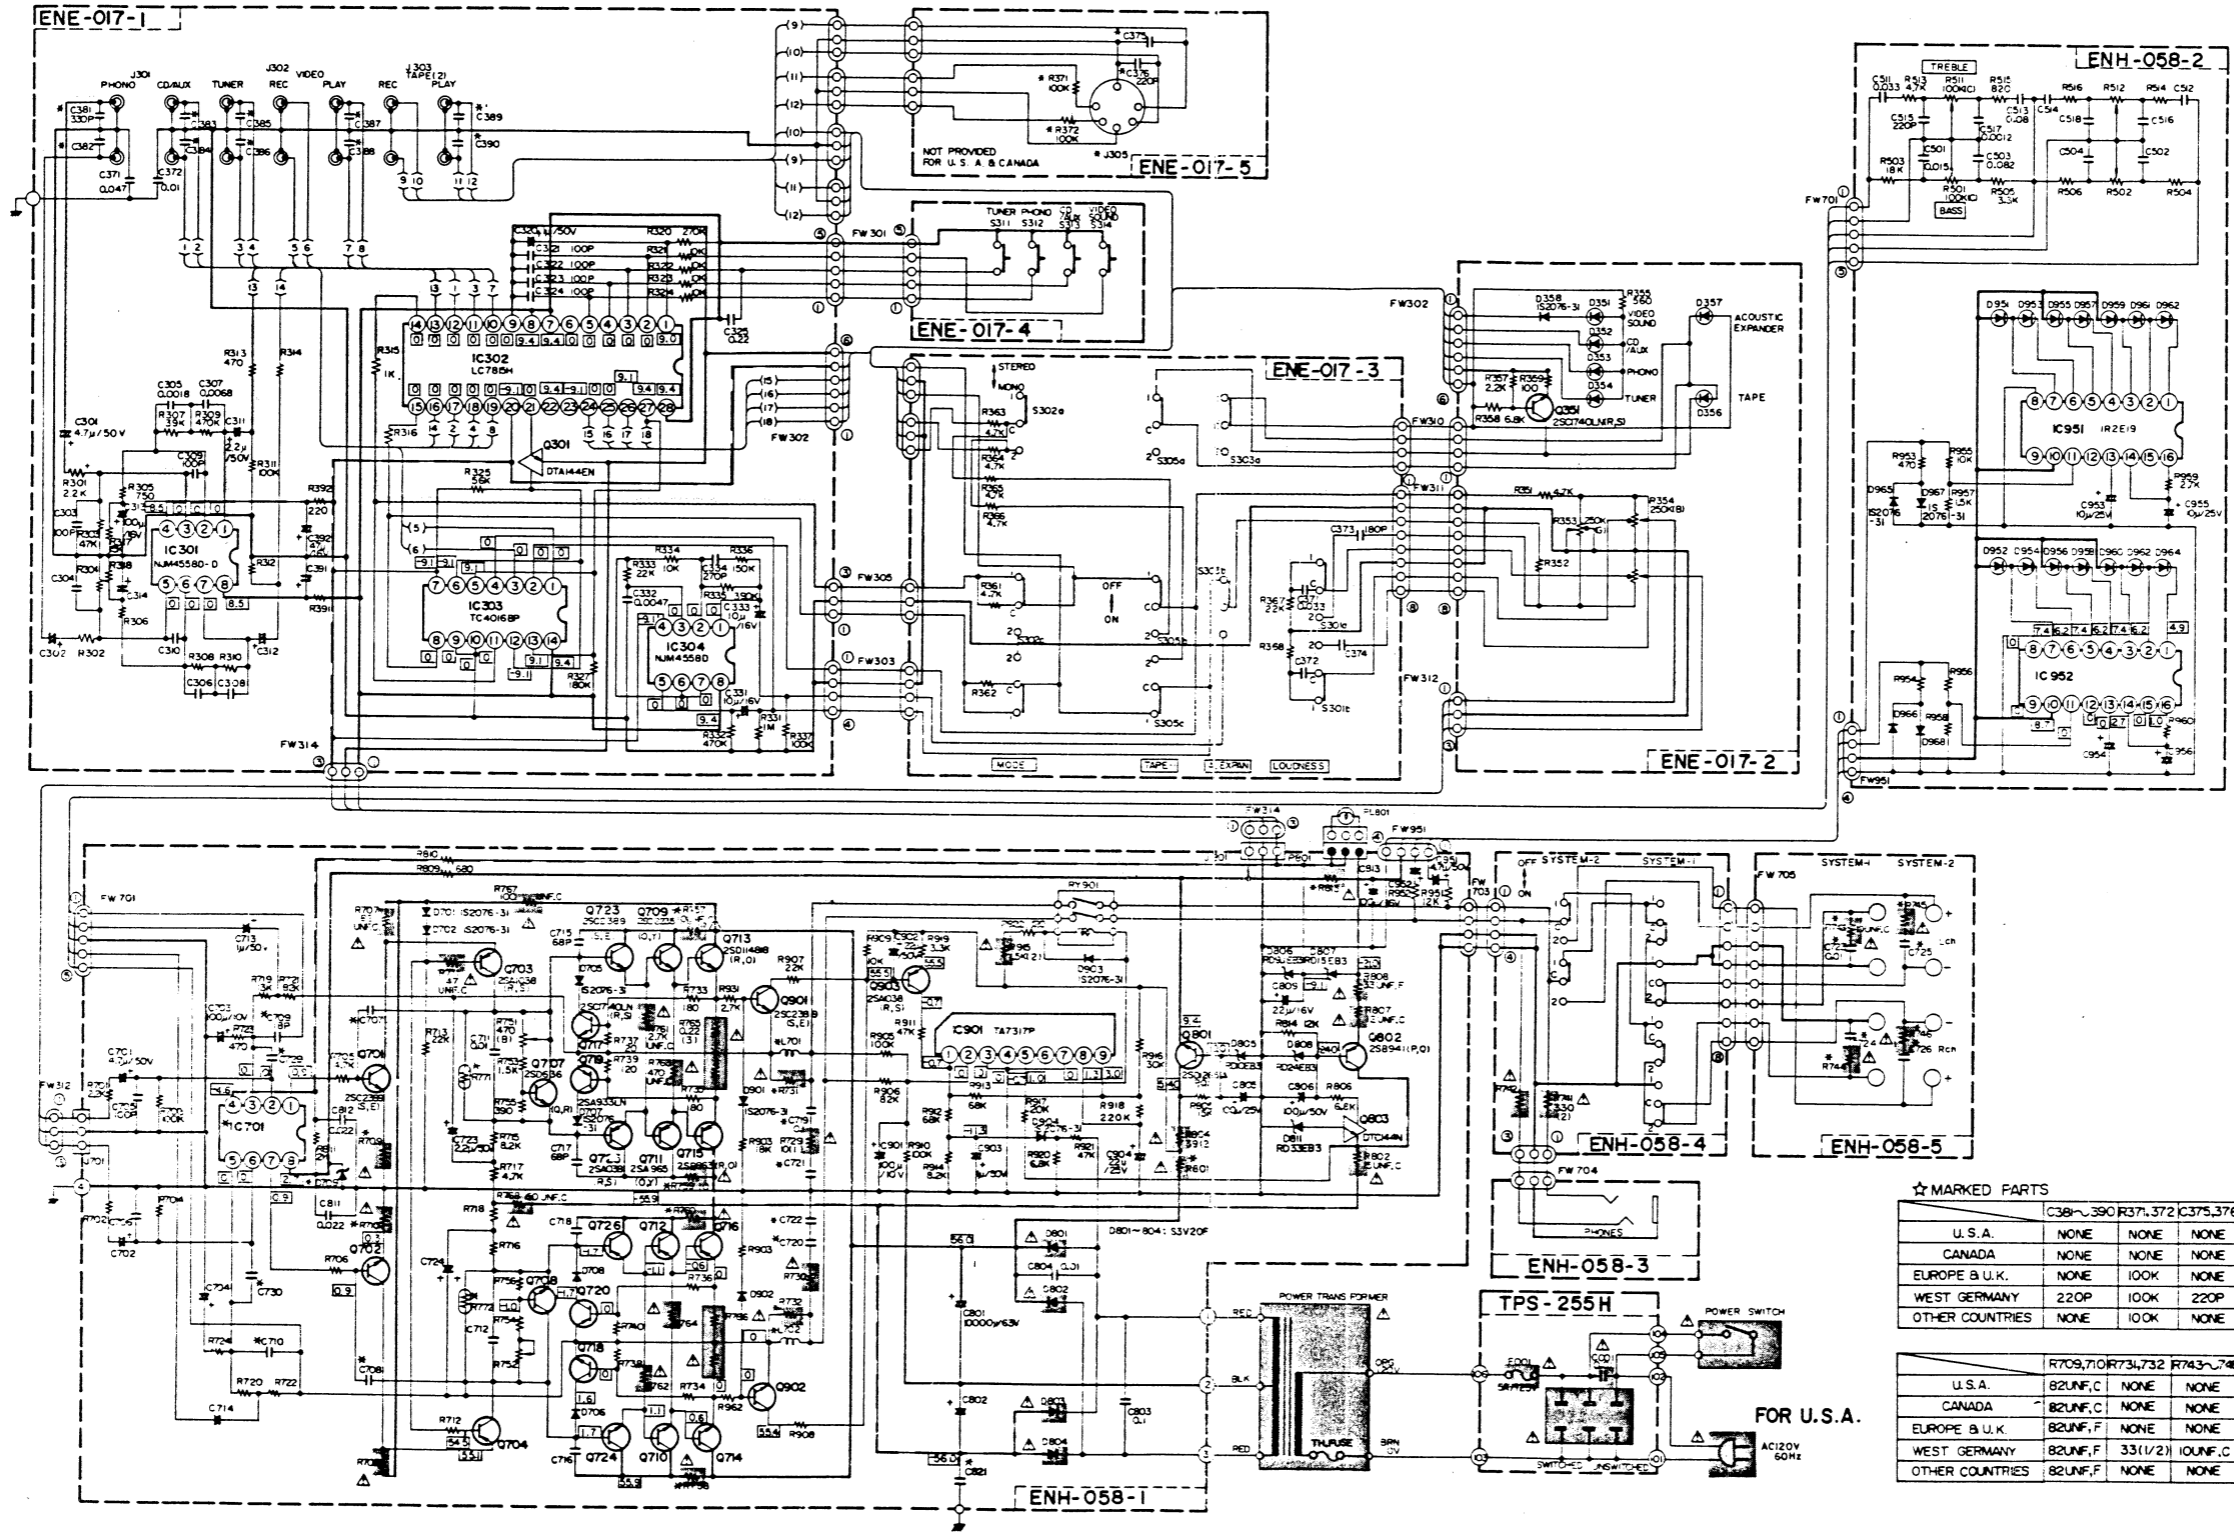
Note:
If the illumination pilot lamp (PL801) for the wind screen is damaged by opening and shortening, do the following:

- (1) Confirm that the parts with the symbol Nos. shown in the table below are defective.
- (2) Replace the diode (D807).

(2) Modification of the diode (D807)
RD12EB3 - RD15EB3
